Alfred and Sophia Mathews Farmhouse
HO-850
Howard County
Glenwood
Ca. 1868
Private

Maryland Inventory of Historic Properties Form

Inventory No. HO-850

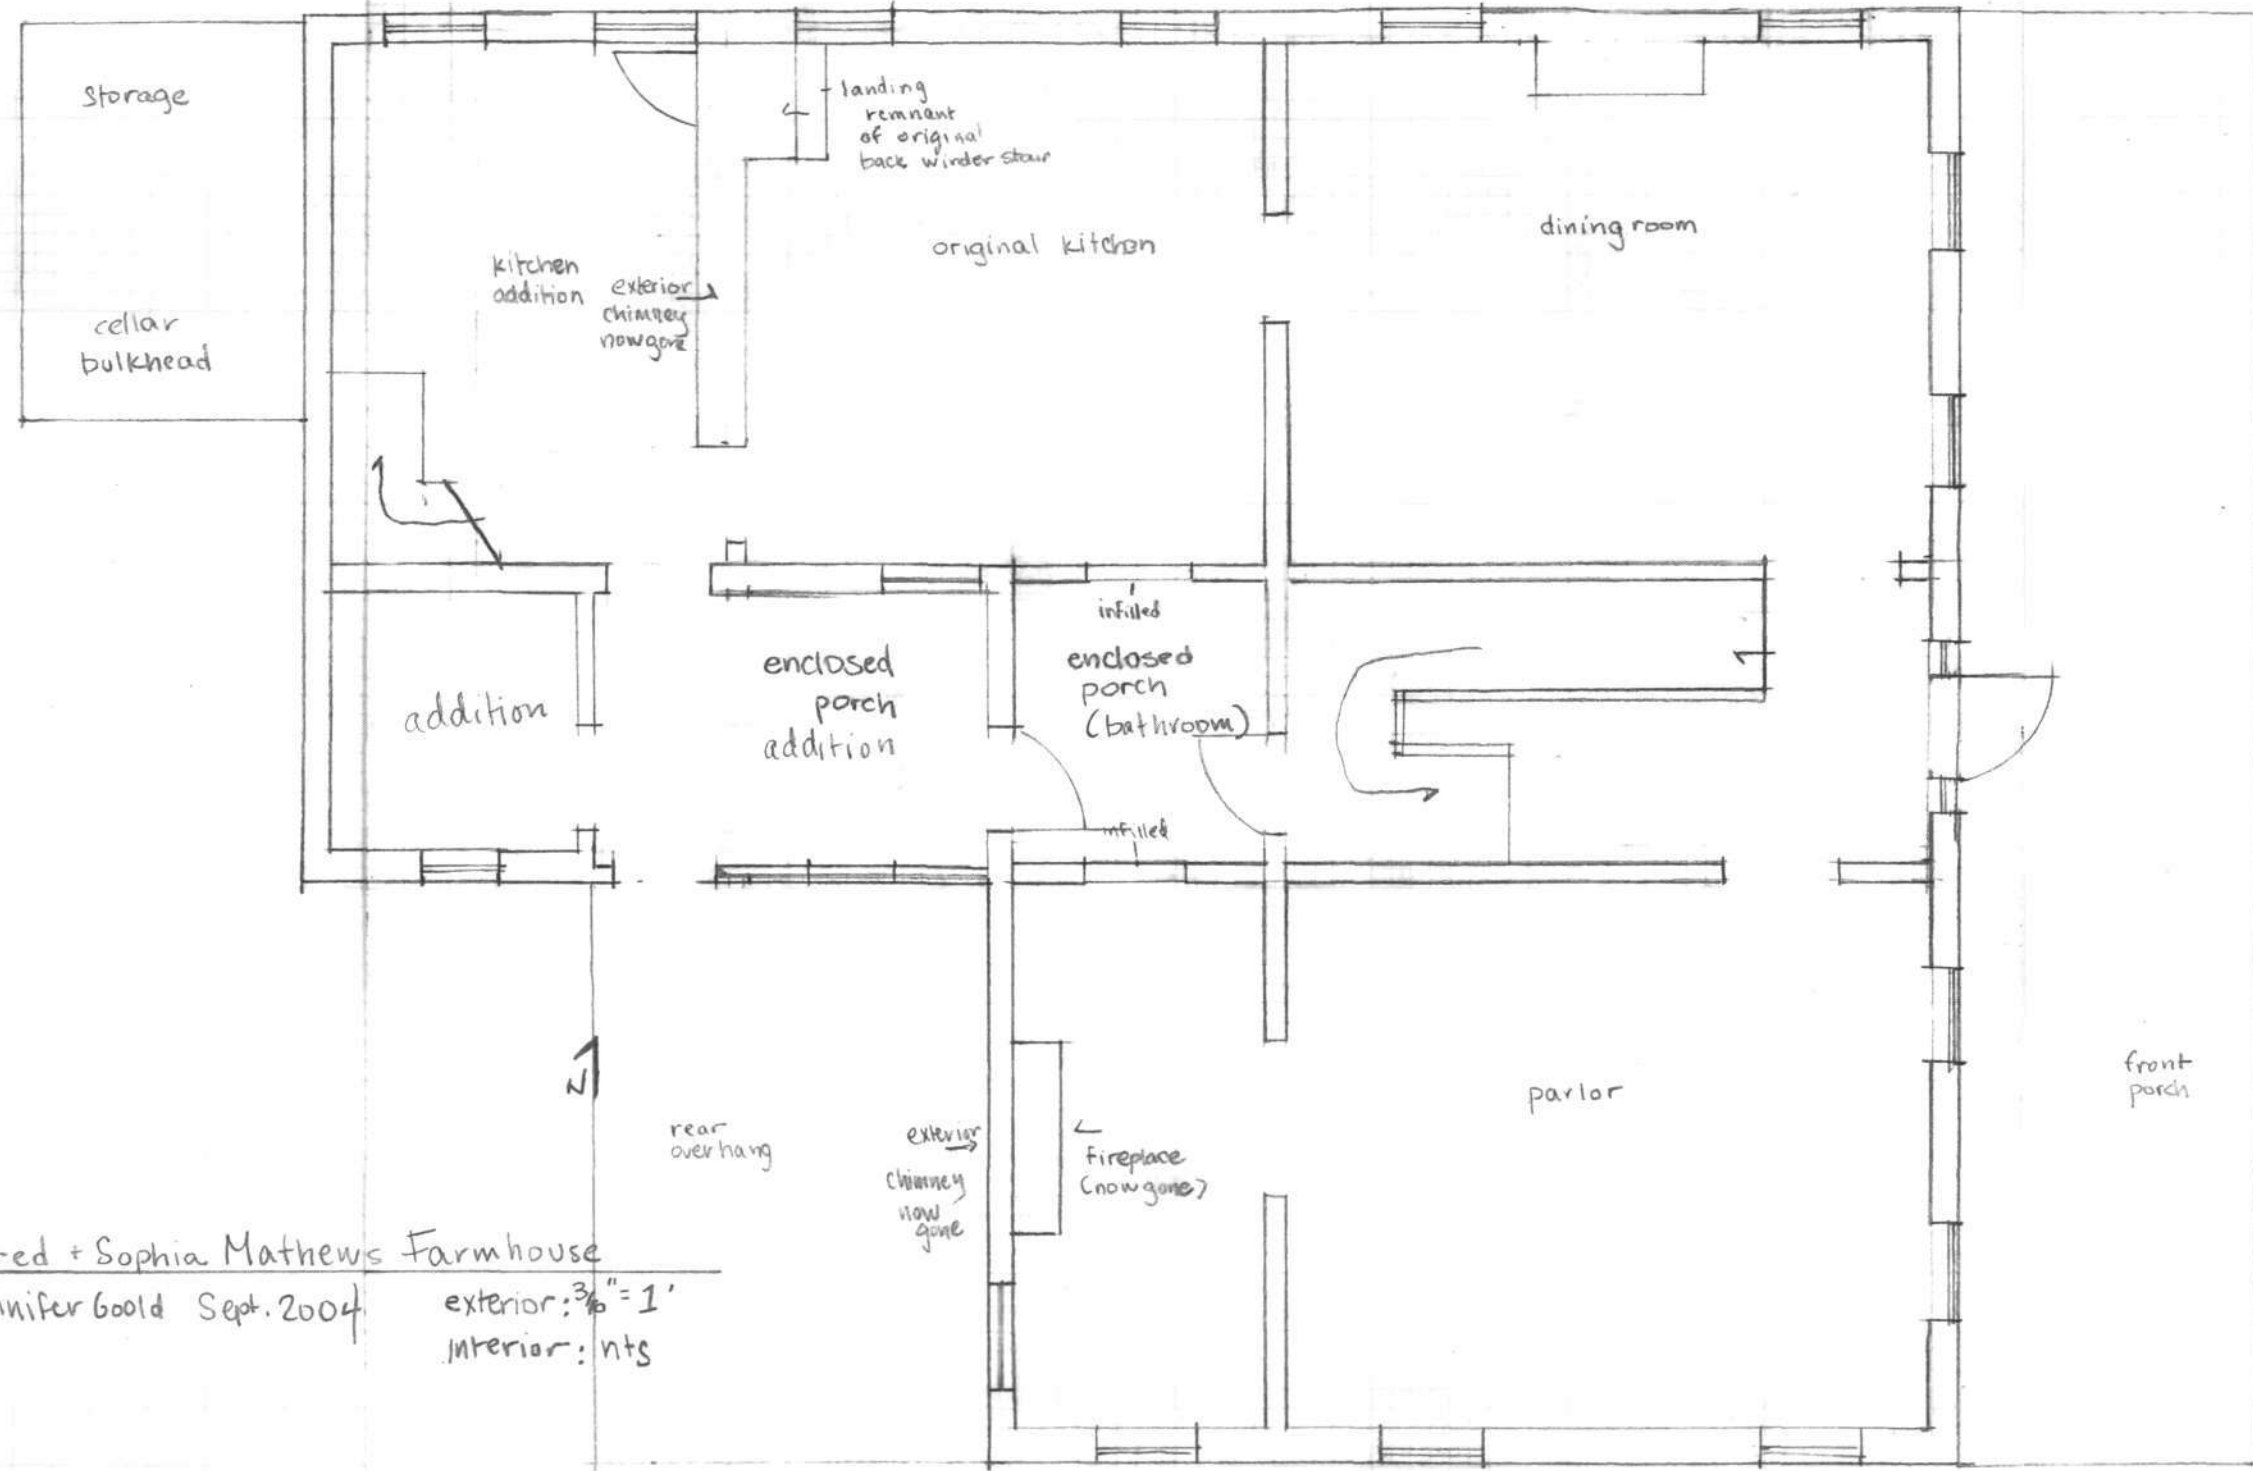
Alfred + Sophia Mathews Farmhouse
Jennifer Gould Sept. 2004
exterior: $\frac{3}{8}" = 1'$
interior: nts

The Albert and Sophia Mathews Farmhouse floor plan consists of a center plan with a rear kitchen ell. There is a small room located behind the parlor and a small porch behind the passage that was later converted to a downstairs bathroom. It is not known whether these rooms are original or additions. An L-shaped 20th c. kitchen addition, comprised of kitchen, storage room, and porch, wraps the south and west sides of the original kitchen ell.

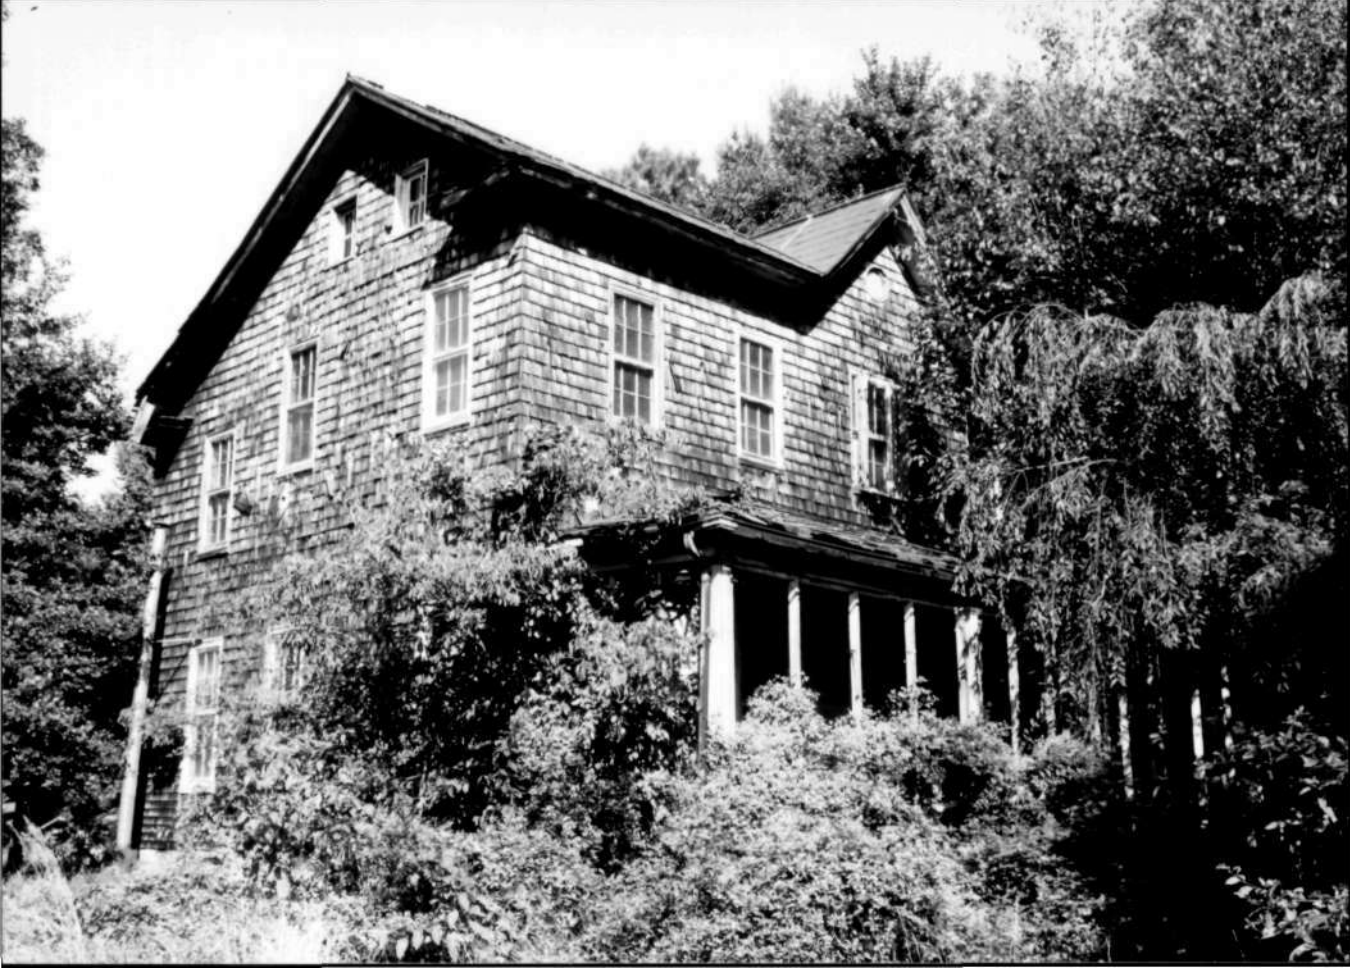
1 of 13

View NW. Shows front facade & south facade.

The primary 5-bay facade of the Alfred and Sophia Mathews Farmhouse faces east. The front (east) facade is symmetrical about its entry bay. The entry bay consists of a wood (replacement) front door with 3-light over 1-panel sidelights and a 5-light transom. Window openings are vertically aligned and graduated. Window openings hold original 6-over-6 wood windows, except for the center opening on the 2nd floor. The center window on the 2nd floor has a tri-partite configuration that mimics the entry door configuration with a 4-over-4 wood window in the center. An attic oculus, now infilled, is centered in the front cross-gable. A full-width front porch with granite piers projects from the front (west) facade. The porch has square wood posts and pilasters and is screened.

The south, gable-end, elevation of the main block of the Alfred and Sophia Mathews Farmhouse is 3-bays wide and is asymmetrical. The deep projecting wood eaves are centered over the parlor. On the 1st floor, two eastern windows light the parlor and the western window lights the smaller back room. Window openings in the 2nd floor are vertically aligned with 1st floor windows and are graduated. Window openings hold original 6-over-6 wood windows. The attic has two 4-light windows centered in the gable end.

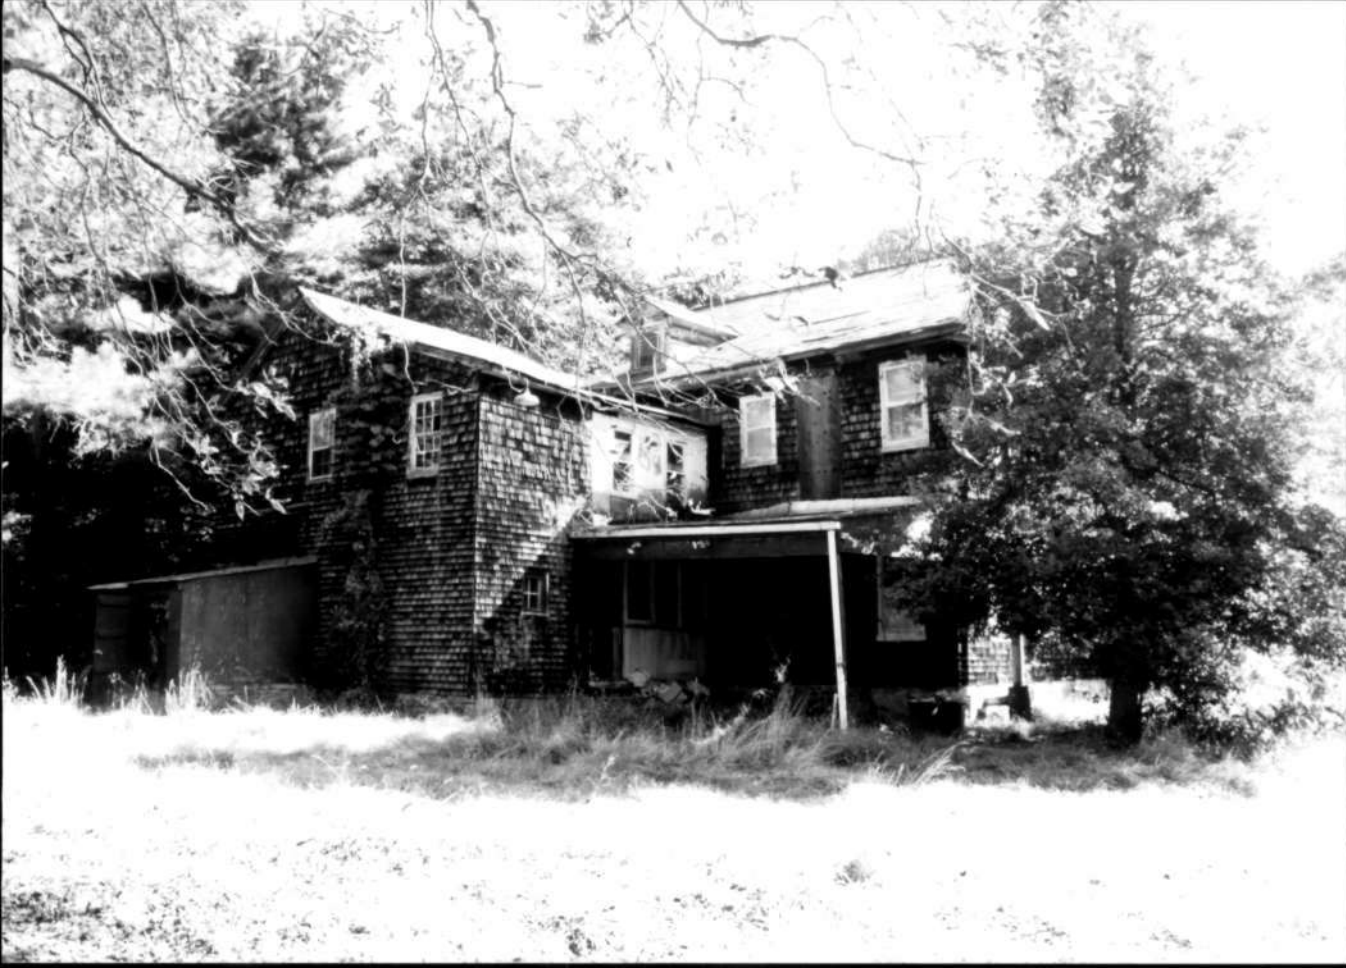
3 of 13

View NE. Shows W facade + rear kitchen ell. Note
scar from demolished chimney.

The two-part kitchen ell of the Alfred and Sophia Mathews Farmhouse projects from the north half of the rear (west) facade. Historically, a massive exterior chimney was centered on the south half of the rear (west) facade. The chimney has been removed and the scar is barely covered with plywood. The 1st floor has one window opening south of the original chimney location. The 2nd floor has two window openings flanking the chimney scar. Window openings are vertically aligned, graduated, and hold 6-over-6 wood windows. A wood dormer, which encloses a wood louver, is centered in the roof at the attic story. A late 20th century, wood drip shed, in very poor condition, projects from the rear (west) facade.

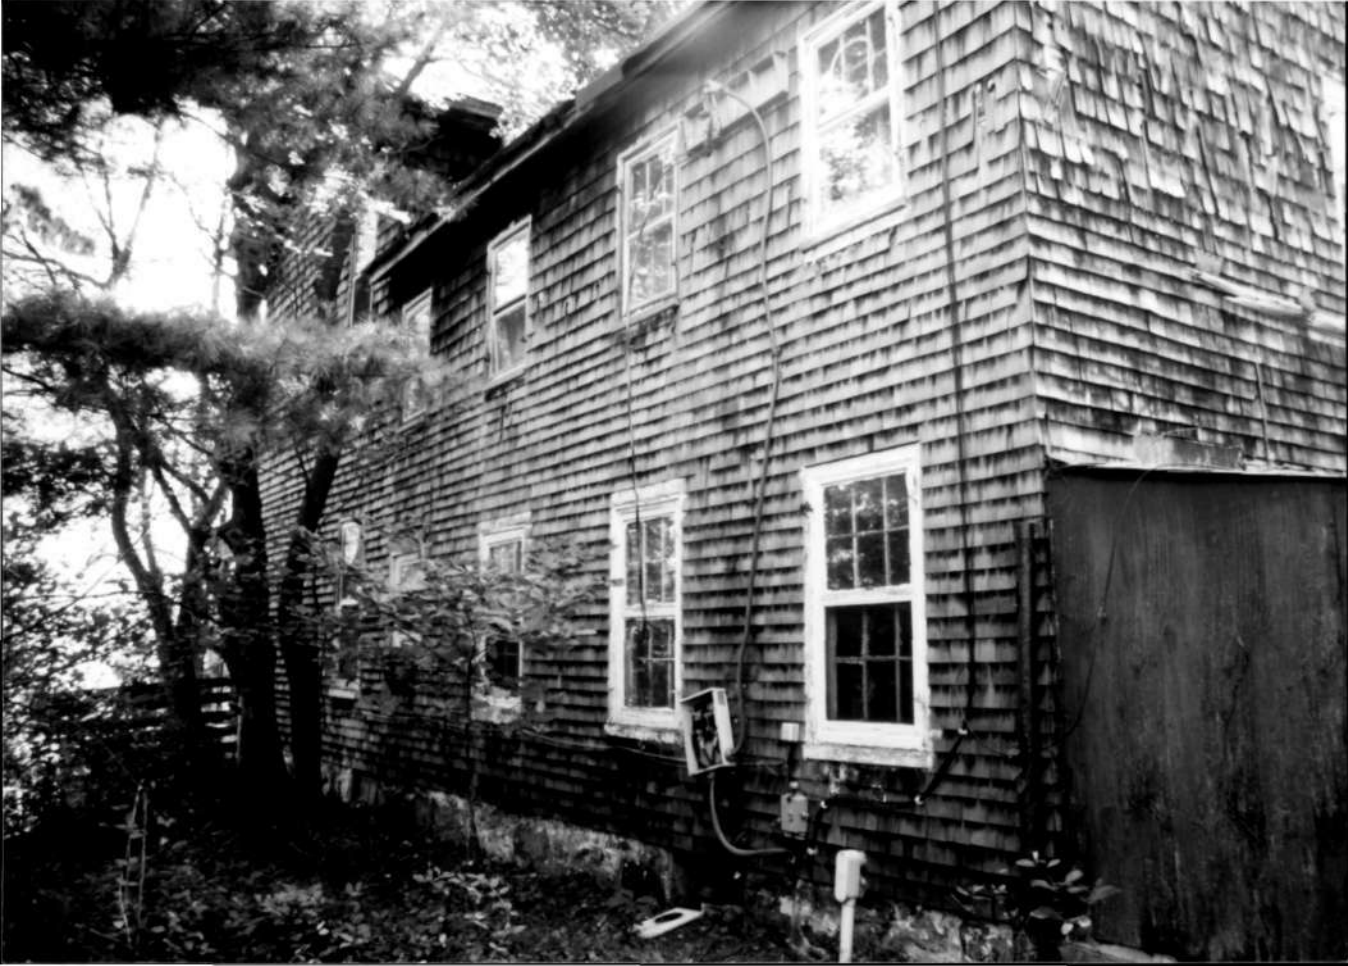
4 of 13

View SE, Shows N-Facade. - Main block, Litchell +
Kitchen addition.

The north elevation of the Alfred and Sophia Mathews Farmhouse is comprised of the main block of the house (dining room), the kitchen ell, and the 20th c. kitchen addition. On the 1st floor, one window lights the dining room and two windows light both the kitchen and kitchen addition. Window openings are vertically aligned, graduated, and hold 6-over-6 wood windows. An interior chimney pierces the roofline in the gable end of the main block.

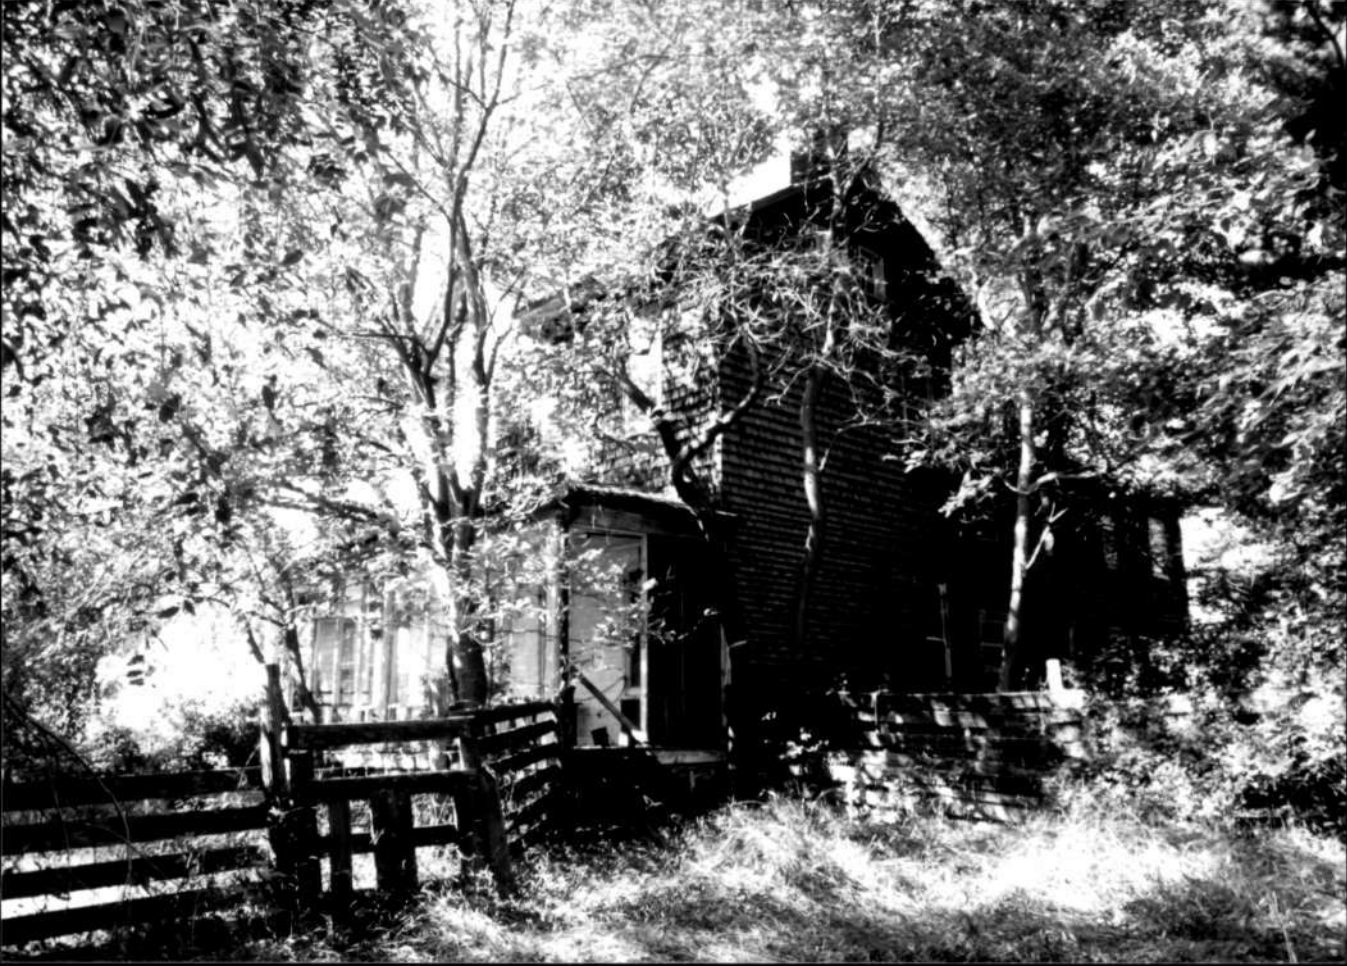
5 of 13

View SW, Shows N + E facades. Note small
pasture N of house.

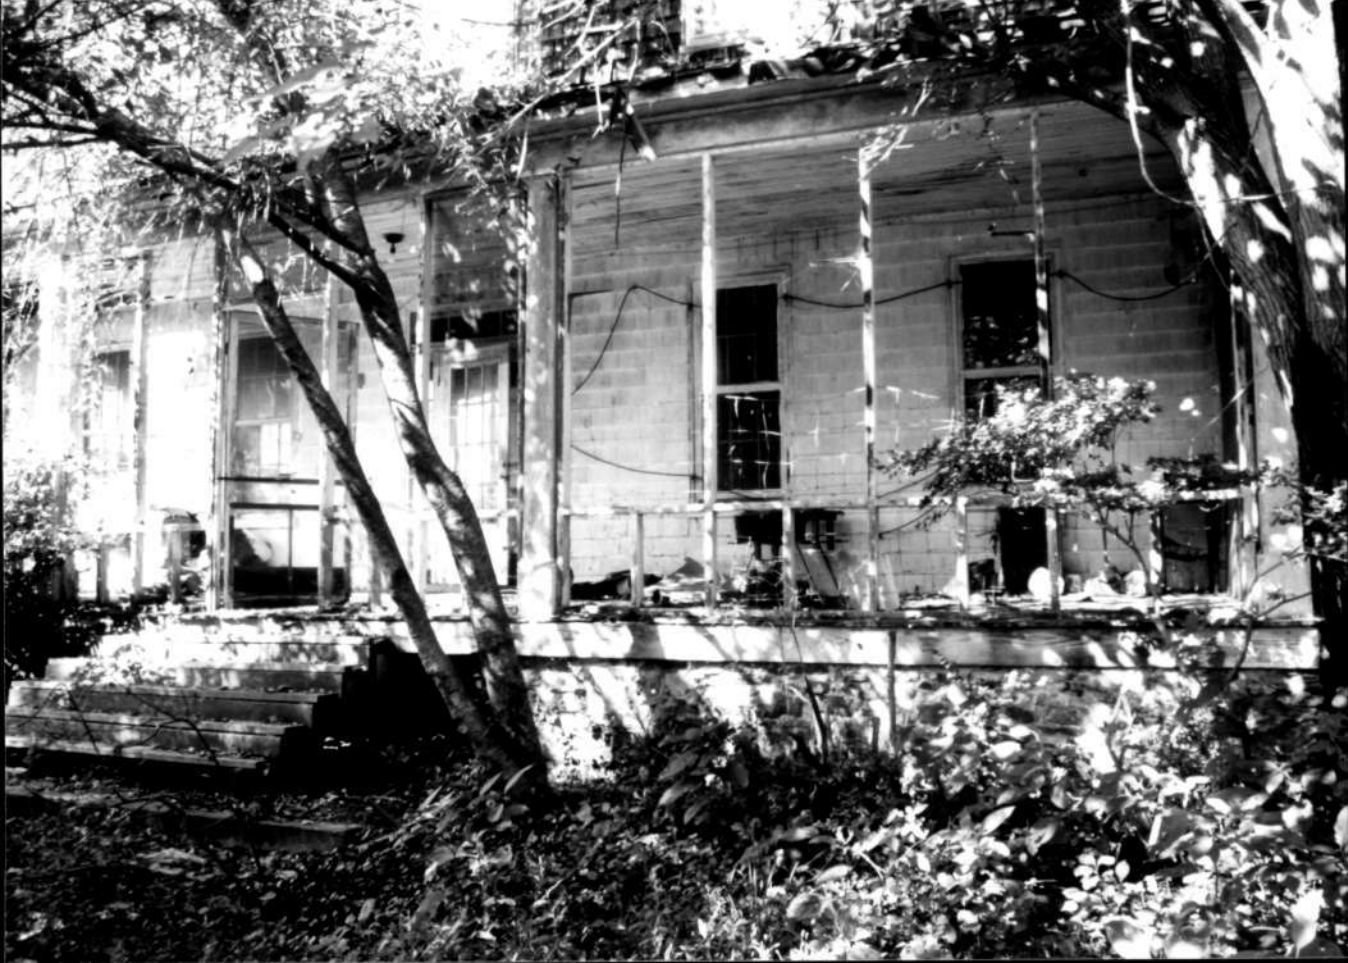
6 of 13

View West, Shows detail of front porch.

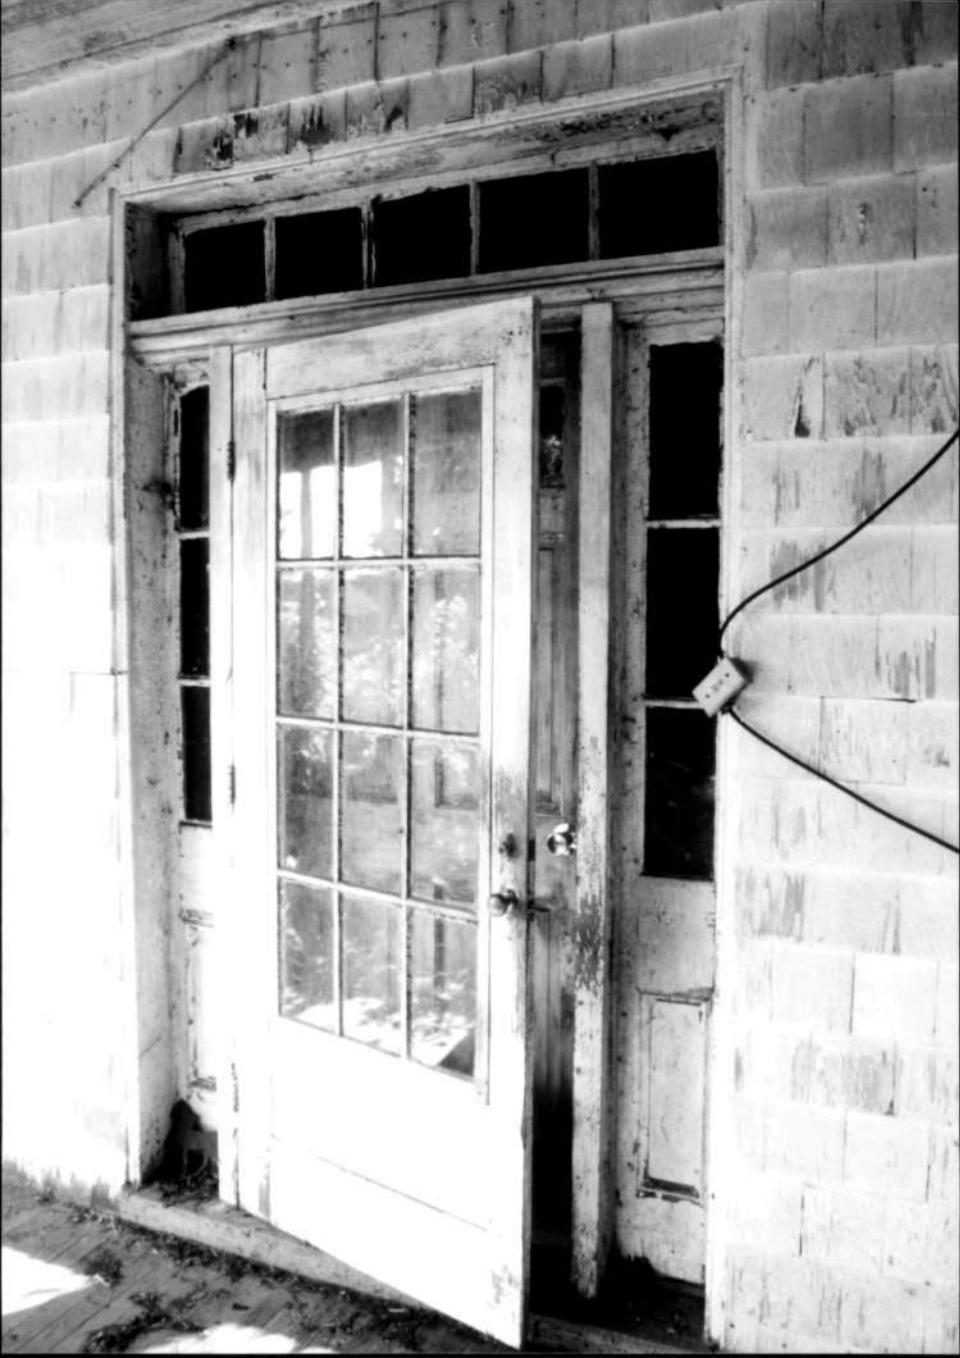
To of B

View west. Shows detail of main entry.

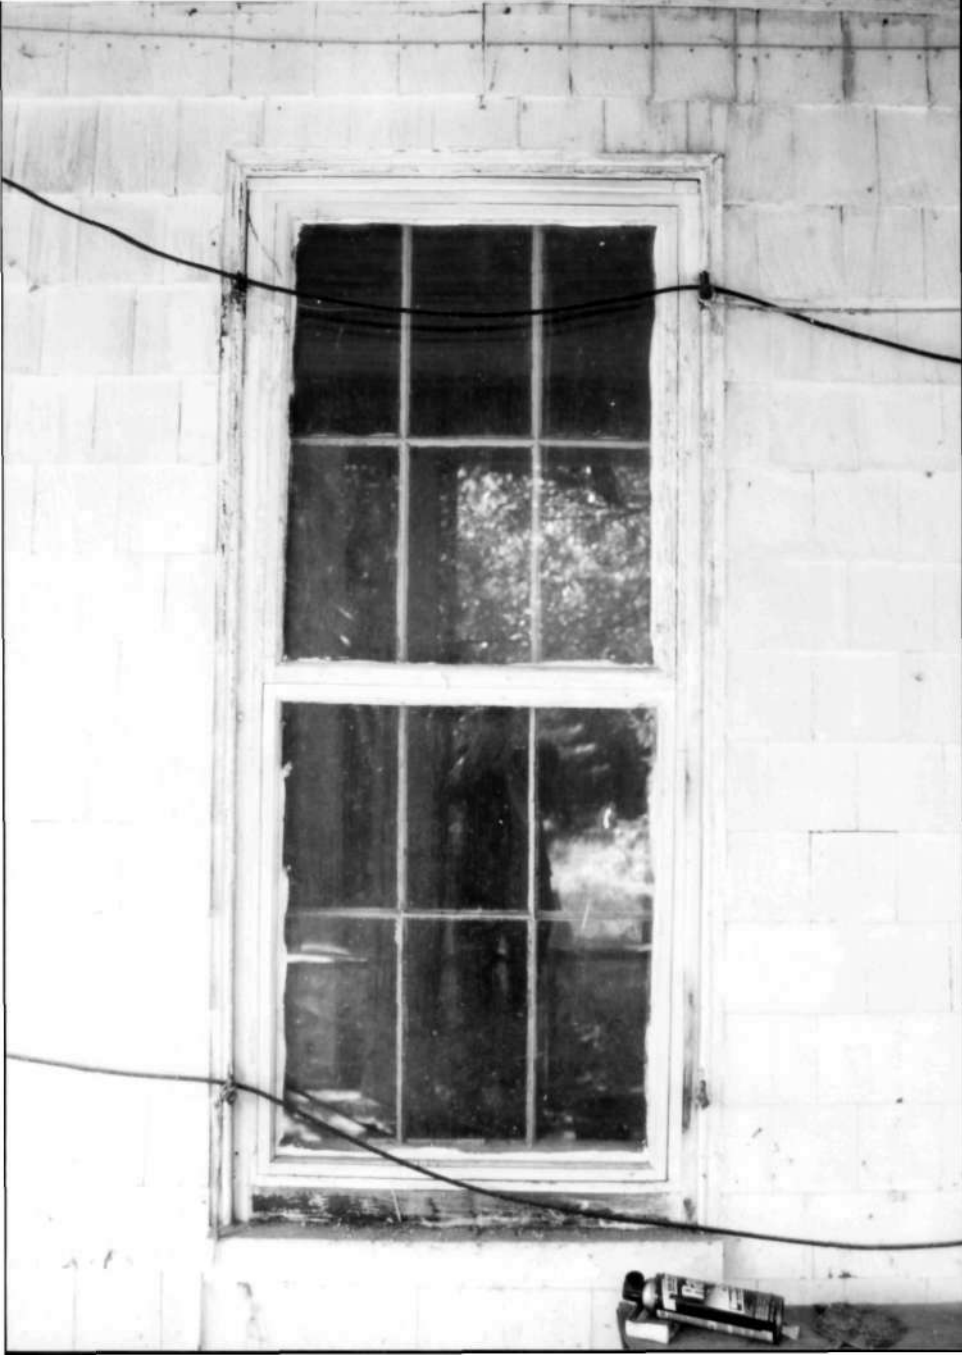
8 of 13

View west. Shows detail of window.

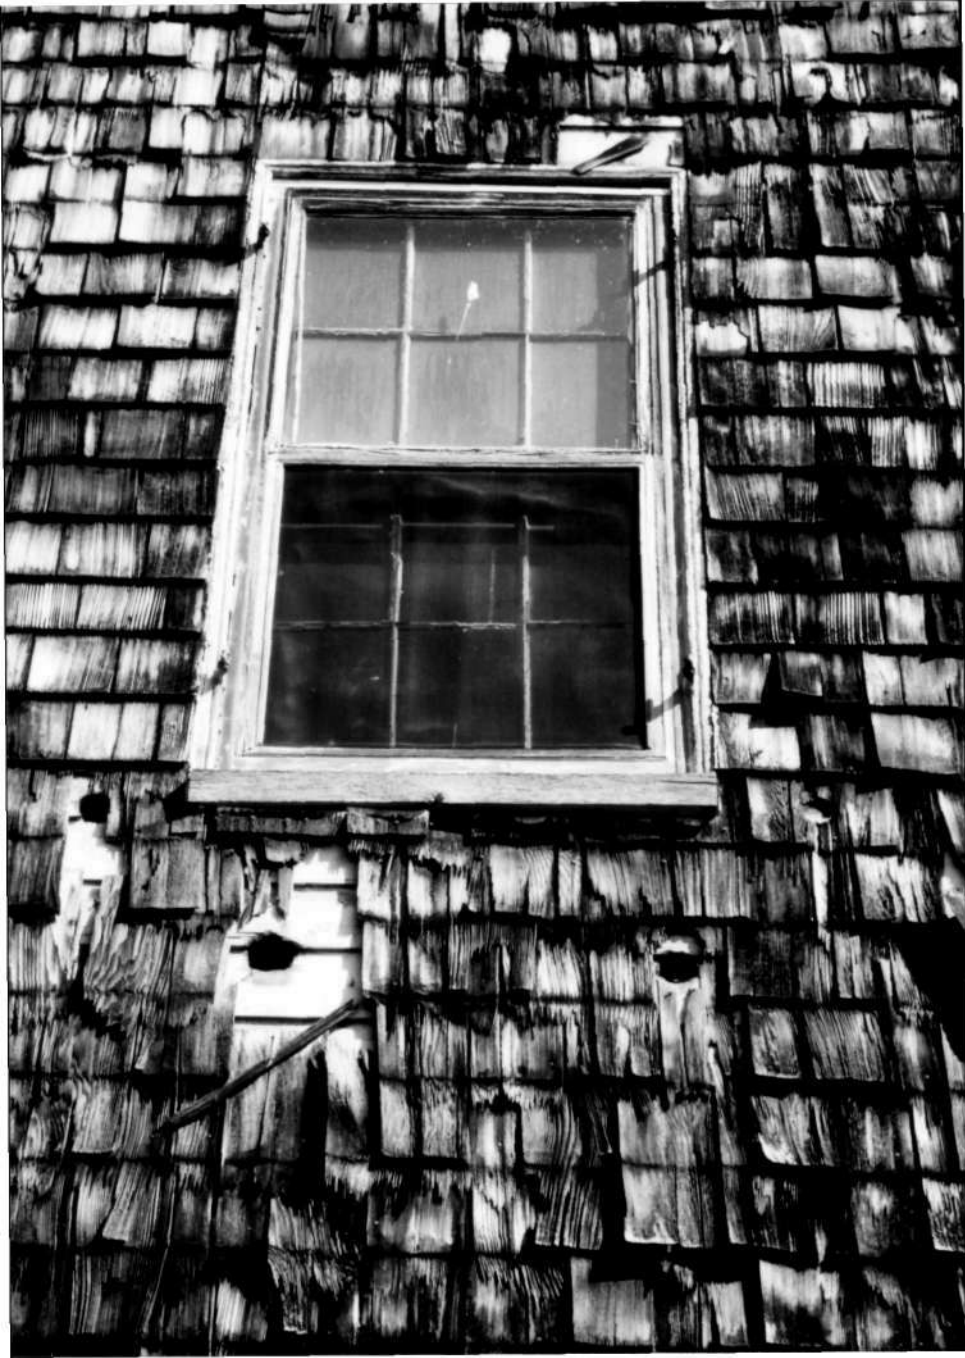
9 of 13

View N. Shows detail of window + German siding
under shingles

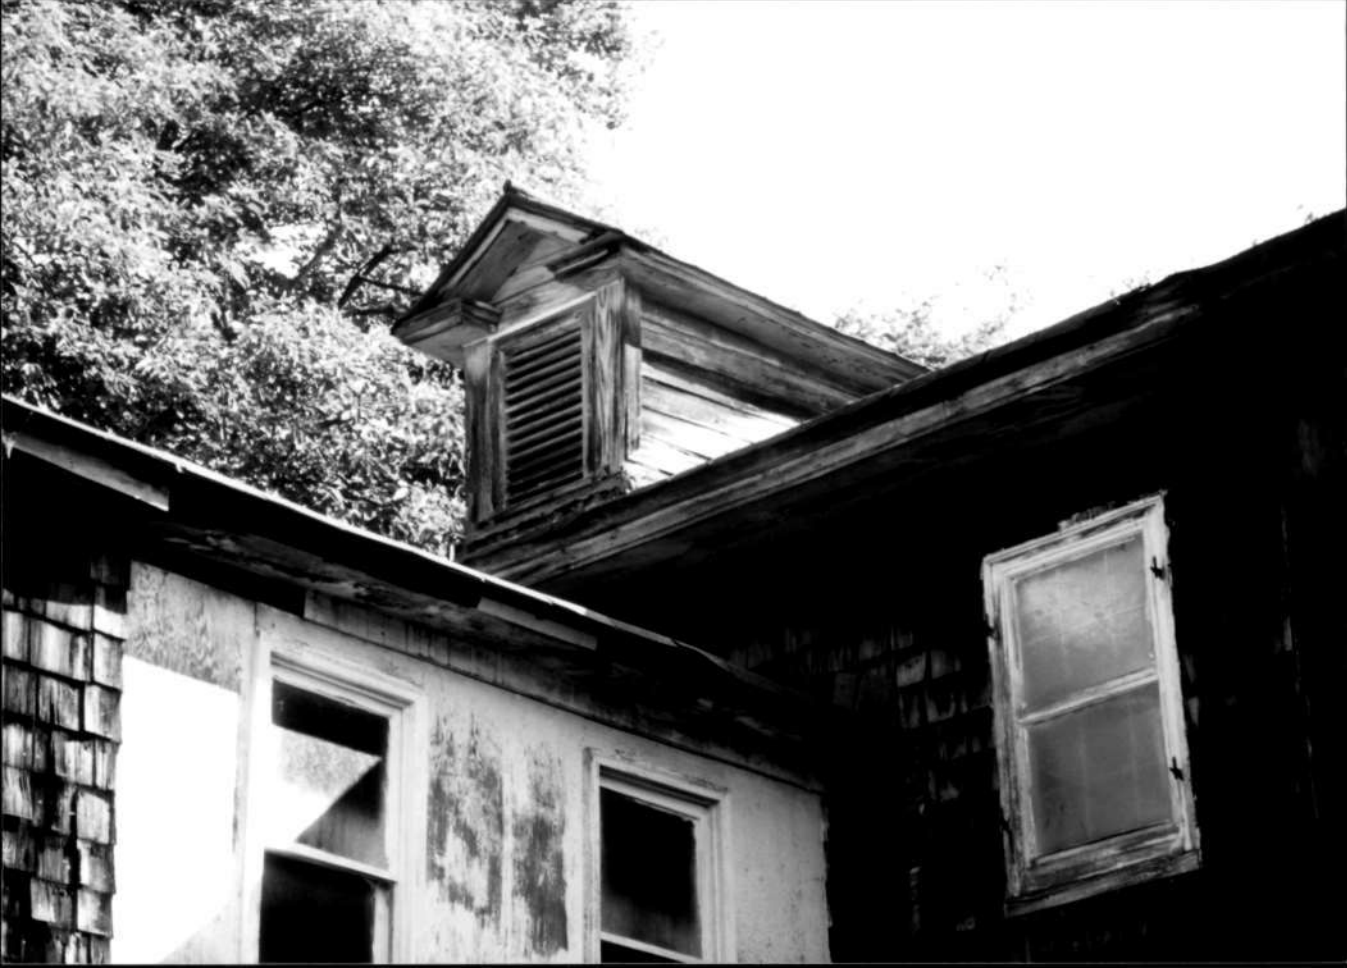
10 of 13

View E, Shows detail of dormer,

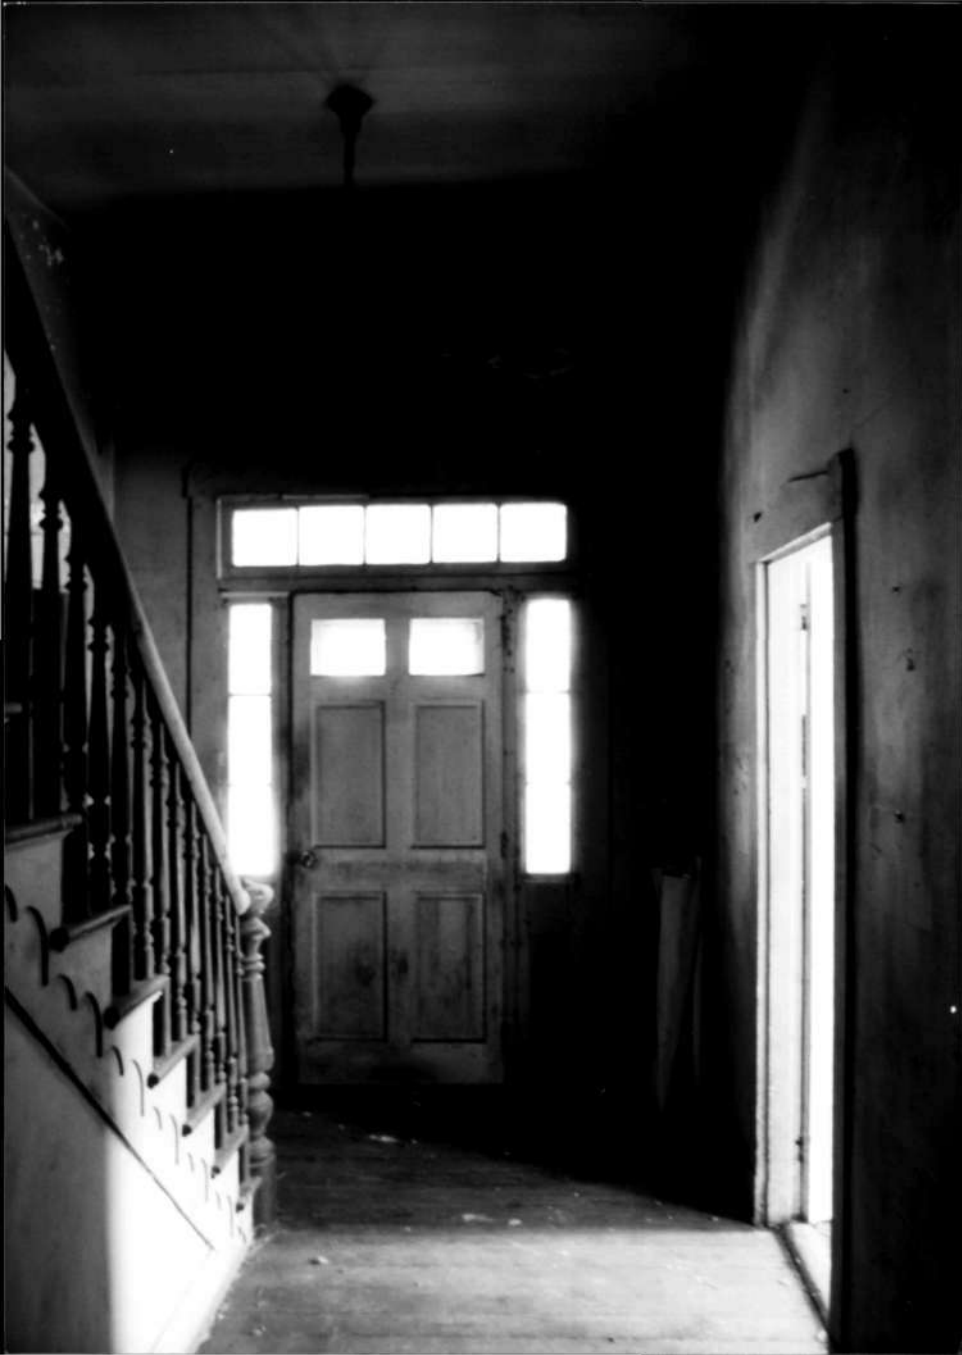
11 of 13

View E. Stair passage, 1st floor.

The front door enters onto the center passage, which runs east-west in the 1st floor. The stair is located on the north wall of the passage and wraps the west and south walls. Door openings to the dining room and parlor are located immediately inside the front door and a door to a small enclosed porch is located at the west end of the passage.

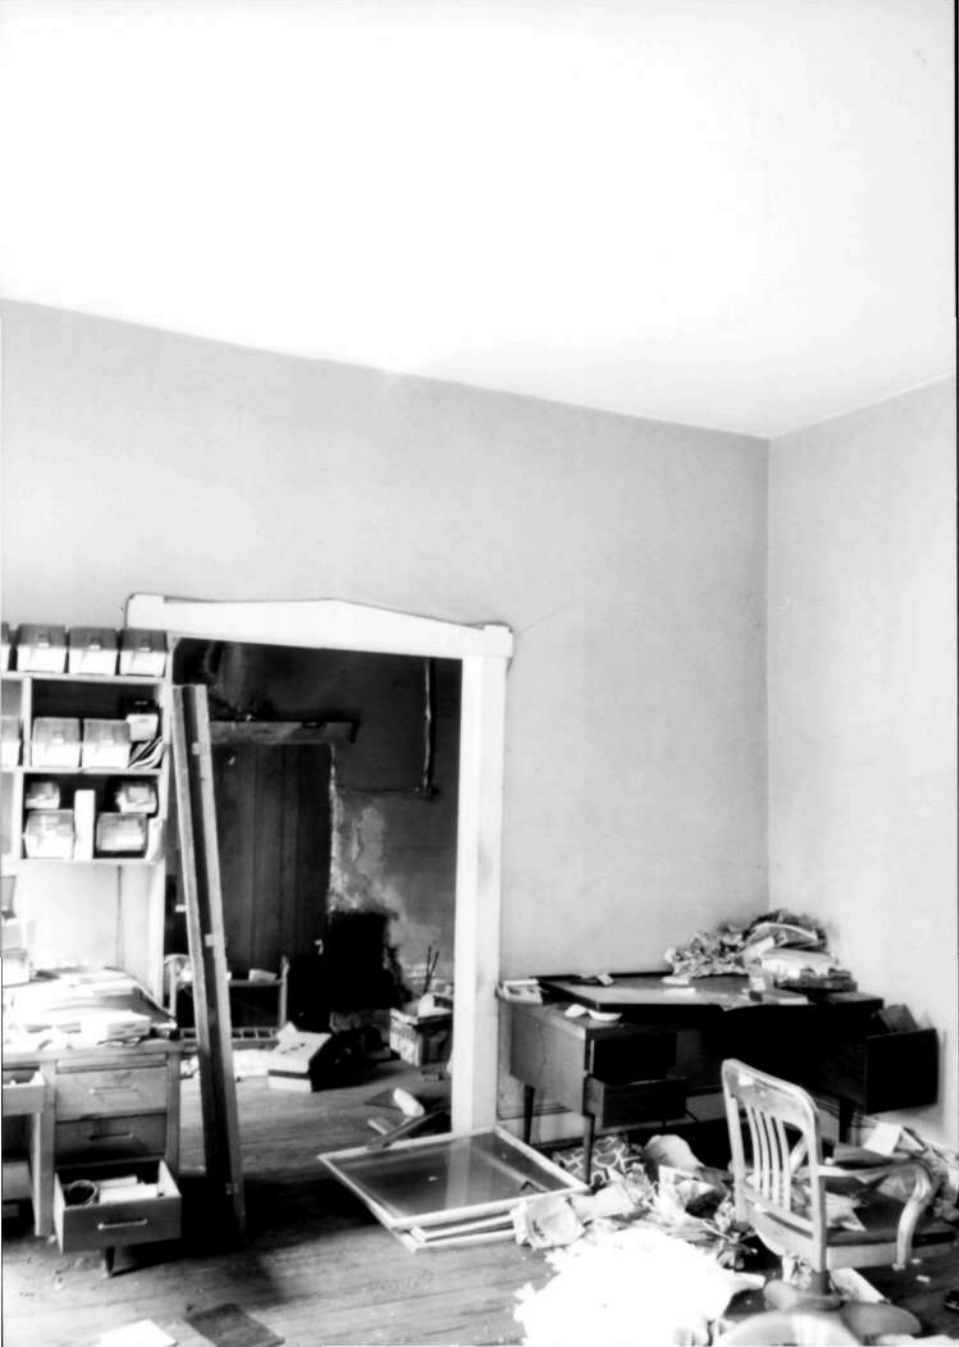
12 of 13

View W. First Floor parlor. Note paneling covering
location of removed fireplace.

The parlor is located south of the passage. The large opening to the small room behind the parlor is located in the west wall of the parlor. The opening to the passage is in the north wall of the parlor.
